**HPC REVIEW FORM:** MCAC 1106

**REQUEST FOR:** Material Change of Appearance Certification (After-the-Fact Replacement of Shingle Siding)

**APPLICANT'S NAME:** Bryan Kingsbury of Construction Factor on behalf of Kevin Maddox

**ADDRESS OF PROPOSAL:** 302 El Paso Blvd. (Red Crags)

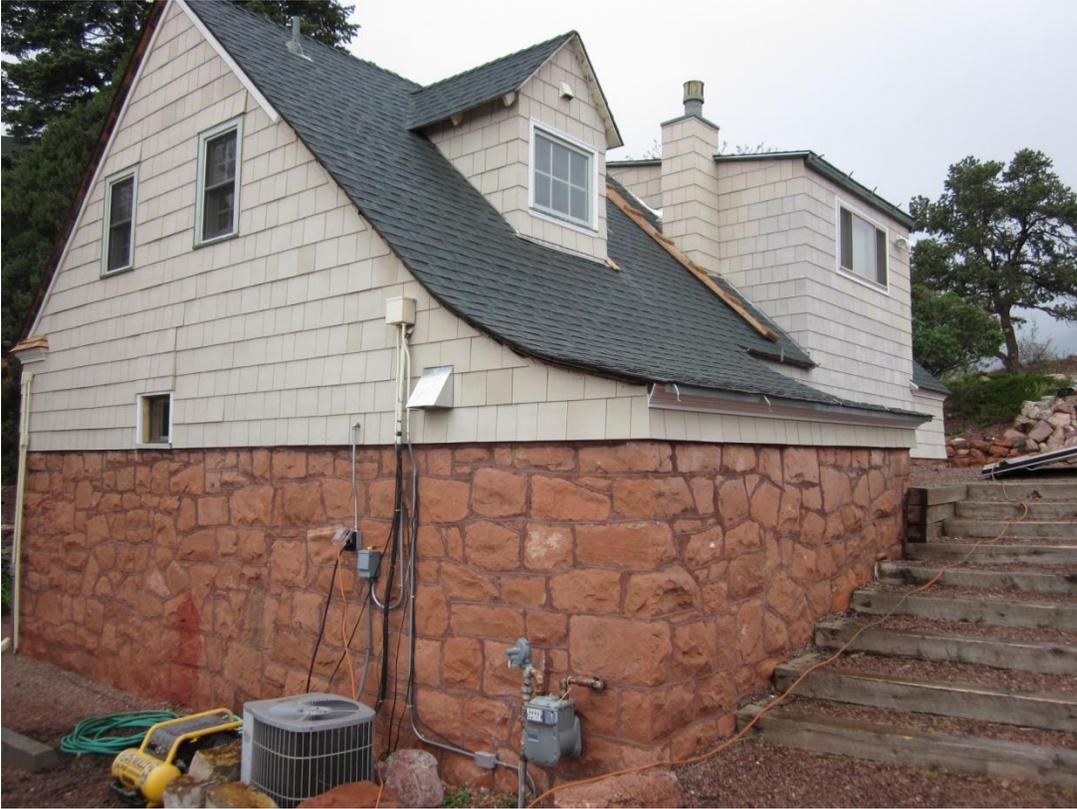
Photo 1. Red Crags Carriage House with replacment shingle siding

Staff finds that the proposed replacement concrete fiber shingle matches the appearance of the wood shingle siding and will not alter the historic character of the building. When the stop work order was issued the Carriage House was about 90% re-shingled with the concrete fiber material, therefore a good example of what the replacement material will look like is easily viewed on site.

- 1) The replacement shingle siding will match the cedar wood siding in appearance as presented to the Commission.
